chapter 7

# biodiversity.

Environment Effects Statement | May 2021

western outer  
ring main

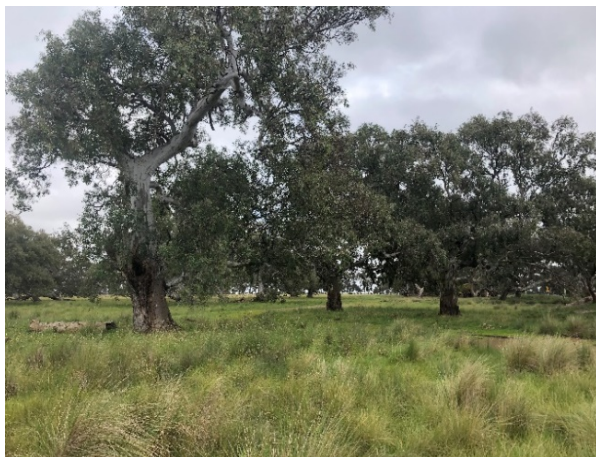
*Figure 7-2 Plains Grassy Woodland/Grassy Eucalypt Woodland of the Victorian Volcanic Plain on private property. Photo: GHD 2020*

Remnant vegetation generally consists of grassland and grassy woodland associated with basaltic soils of the VVP (Figure 7-2). Some patches of Plains Grassland or Plains Grassy Woodland were also recorded, which also meet condition thresholds for EPBC Act-listed communities Natural Temperate Grassland of the Victorian Volcanic Plain and Grassy Eucalypt Woodland of the Victorian Volcanic Plain.

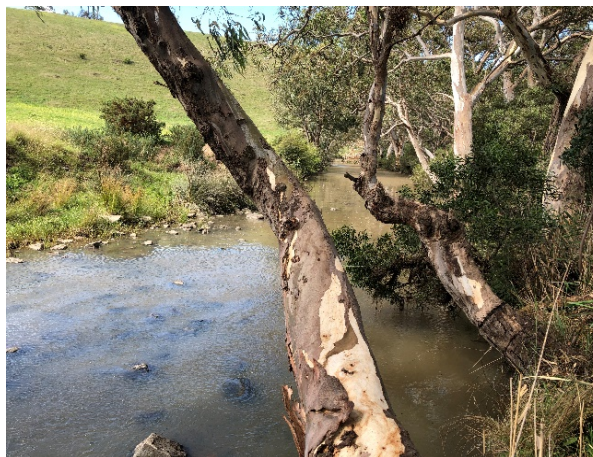
*Figure 7-3 Riparian Woodland at Jacksons Creek: overhanging trees (left). Photo: GHD 2020*

Riparian Woodland (EVC 641) was mapped at each of the three major stream crossings (Deep Creek, Jacksons Creek and Merri Creek). These riparian corridors along the three waterways provide the most contiguous areas of native vegetation (Figure 7-3). Large trees, which provide important habitat value, were also recorded in all three Riparian Woodland patches.

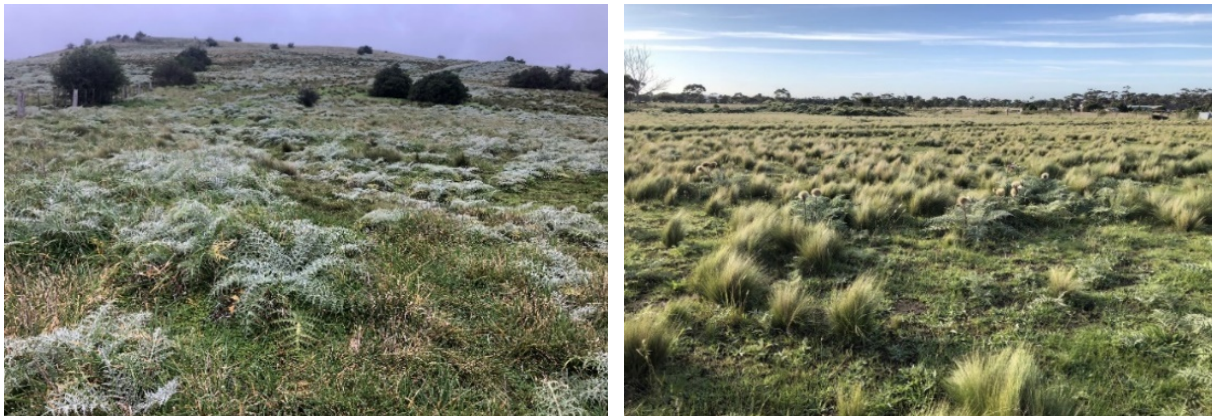
Figure 7-5 Artichoke Thistle and Serrated Tussock

Noxious weeds can cause environmental or economic harm and are listed depending on their invasiveness and their management requirements.

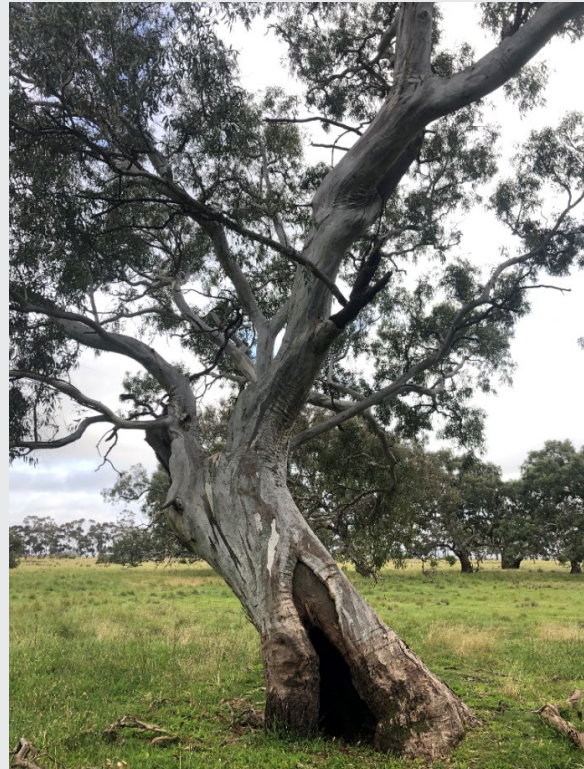
### What is woodland habitat for fauna?

Native and non-native trees, some of which are hollow-bearing provide foraging, nesting and roosting habitat for fauna. Remaining woodland also provides a network of connectivity for fauna that disperse widely across the landscape (for example, birds, mobile reptiles and mammals).

The condition of woodland within the construction corridor varies widely. Larger patches of remnant woodland are typically of very high quality for woodland fauna and more likely to support threatened fauna (for example, Swift Parrot). Smaller and narrower patches tend to be of medium quality, but still of value for fauna dispersal. Patches of newly-planted or non-native woodland are typically of low value for woodland-dependent fauna.

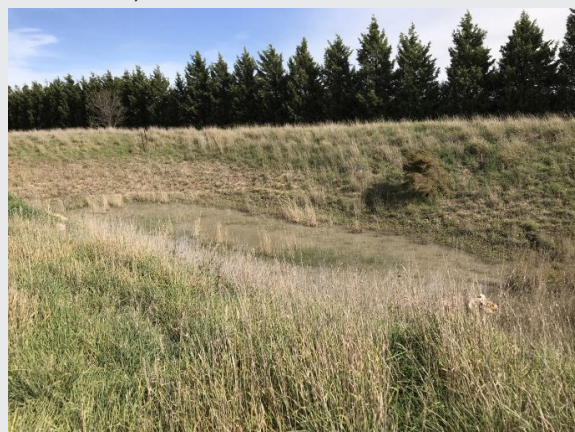
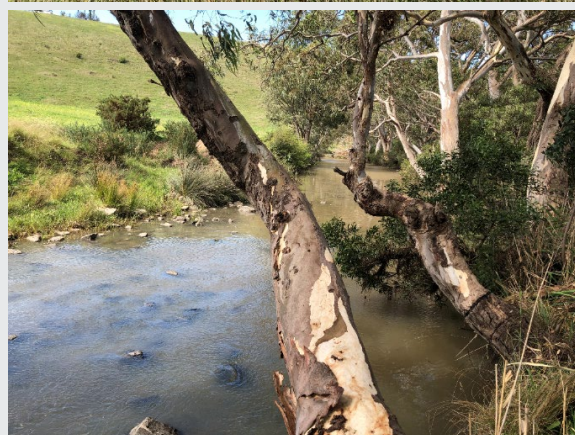
### What forms waterway and wetland habitats?

Waterways for the construction corridor include creeks, farm dams and other off-stream waterbodies. The construction corridor crosses three main waterways (Jacksons Creek, Deep Creek and Merri Creek).

Farm dams assessed were of varying quality with some supporting a high cover of submergent and floating aquatic vegetation through to those that were dry when assessed in the summer of 2019/2020. The majority of dams were considered relatively isolated with a low cover of aquatic vegetation. It is acknowledged that under the right conditions, some of the currently dry wetlands may re-establish. However in the state in which they were initially assessed, most do not offer habitat for many wetland or aquatic fauna. Subsequently, all dams outside the MSA area identified as dry during the summer of 2019/2020 were determined to be wet during November/December 2020.
