technical report D

land stability and ground movement.

Environment Effects Statement | May 2021

The Western Outer Ring Main Project (the Project) is a buried 600 millimetre nominal diameter high pressure gas transmission pipeline between APA's existing Plumpton Regulating Station (approx. 38 kilometres north west of Melbourne's CBD) and Wollert Compressor Station (approx. 26 kilometres north of Melbourne's CBD), providing a high pressure connection between the eastern and western pipeline networks of the Victorian Transmission System (VTS).

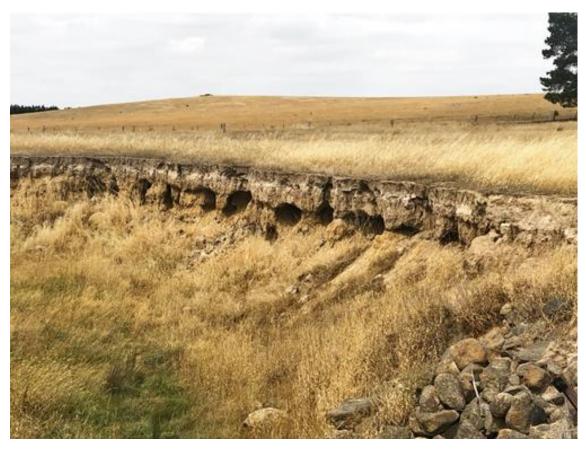
Figure 6-2 Example of eroded dispersive soils near the town of Beveridge (GHD, 2020)

As a consequence of the presence of saline water in the soils, there is the potential for dispersive behaviour ("sodicity") in fine grained residual soils. The more abundant cations dissolved in the pore water in these soils means that the exchangeable sodium amounts are higher, and thus the risk of dispersivity of the soil when exposed to fresh water may be greater. An example of eroded dispersive soils within the Project area is shown in Figure 6-2 below.
